**BULLETIN 34180**

**AUTOMATIC BRAKE FUNCTION**

**UPON MINECRUISER SERVICE BRAKE**

**FAILURE**

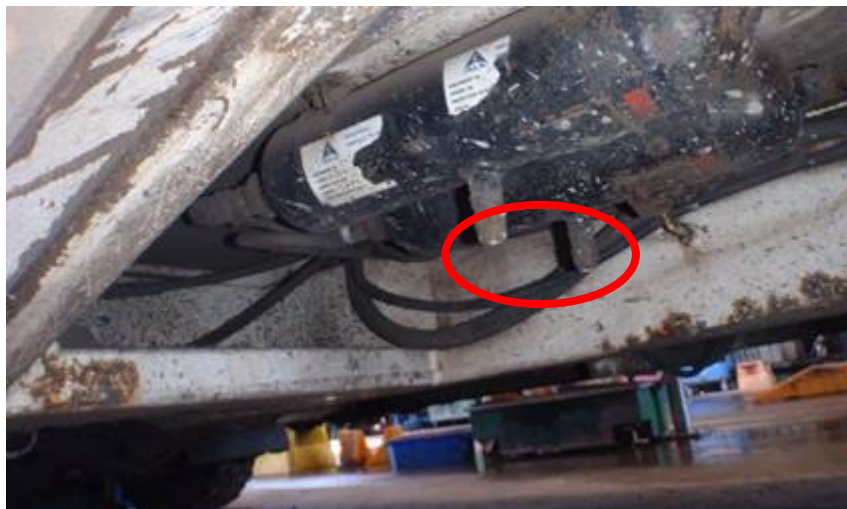
Recently a Minecruiser Mk7 was involved in an incident whereby the service braking system did not function as intended when brake system pressure was lost as a result of impact damage to reservoir drain fittings. When the brake system pressure was lost, the automatic brake system failed to automatically apply the brakes. The Minecruiser was subsequently involved in a collision.

**Damaged service brake reservoir fittings**

1. CONFIRM activation of automatic braking system and engine shutdown when system air pressure approaches the lower limit. This should occur between 280-200 Kpa.

2. Fitment of mechanical means of protection is recommended in vehicle configurations where brake system reservoir/accumulator drain fittings are vulnerable to impact damage.
